5596SL LCD Ground Strap Retrofit

Retrofit for 5596SL to prevent a static discharge from blanking out the LCD display.

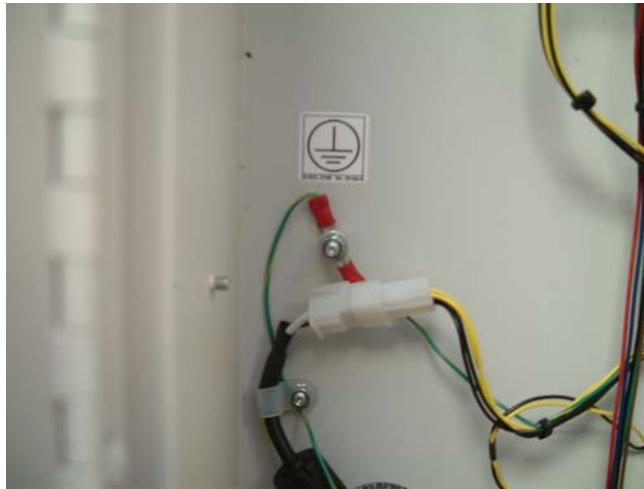
1. Unplug the power cord from the 5596SL coin box
2. Open up the 5596SL coin box
3. Remove the coin changer
4. Locate the ground wire provided in this retrofit package
5. Remove the 7 mm nut holding the ground wires to the chassis

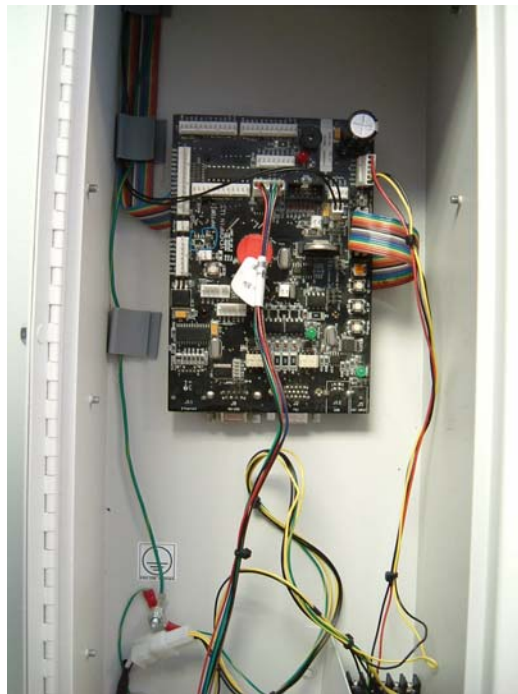
6. Place one end of the LCD ground wire over the stud
7. Replace the nut holding both ground wires

8. Route the ground wire through the plastic clips that hold the LCD wire.
Note: the plate holding the power supply and coin changer has been removed for clarity.

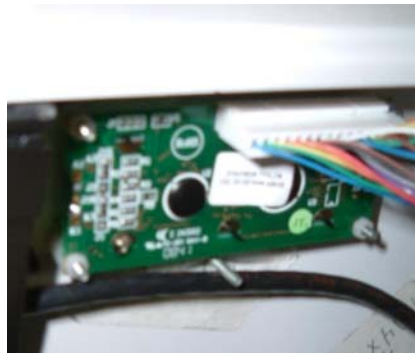
9. Locate the LCD module in the coin box

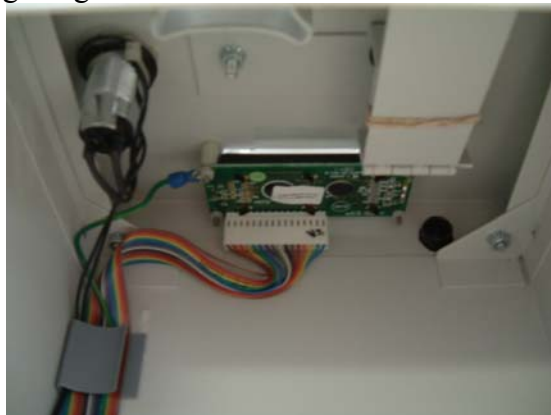
10. Remove one of the 3/16" nuts holding the LCD module in place
11. Place the other end of the LCD ground wire over the stud
12. Replace the nut holding the ground wire to the LCD module

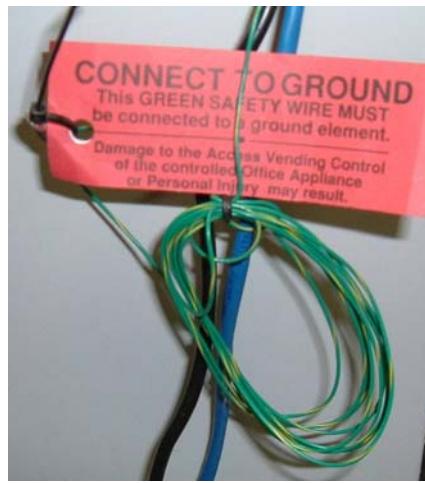
13. Locate chassis ground wire with the red caution tag on it

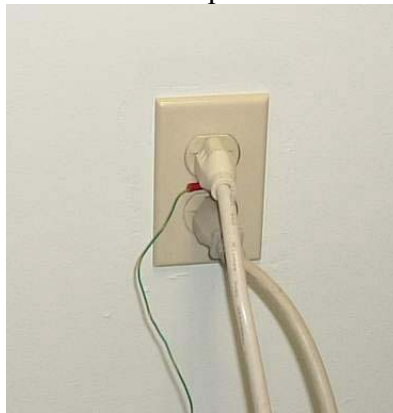
14. Remove the center screw from the electrical plate and attach the ground wire
